Close Out Documents

AP-49A – 2381 E 46th Ave.

Asbestos Abatement and Structural Demolition

Re: SSCR AP-49A 2381 E 46th Ave.

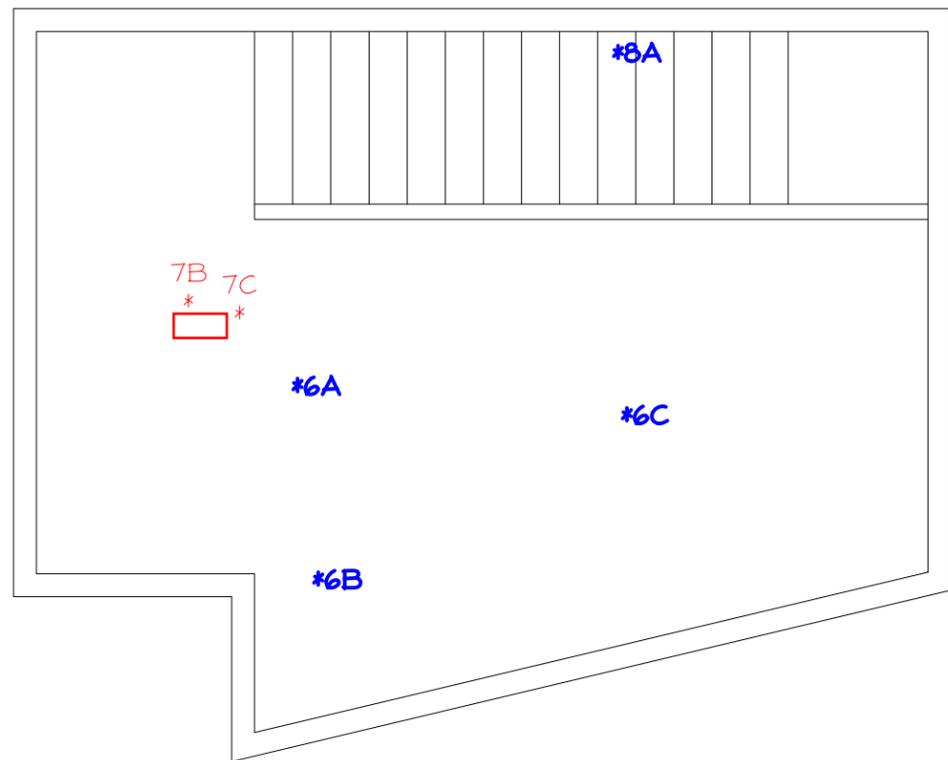
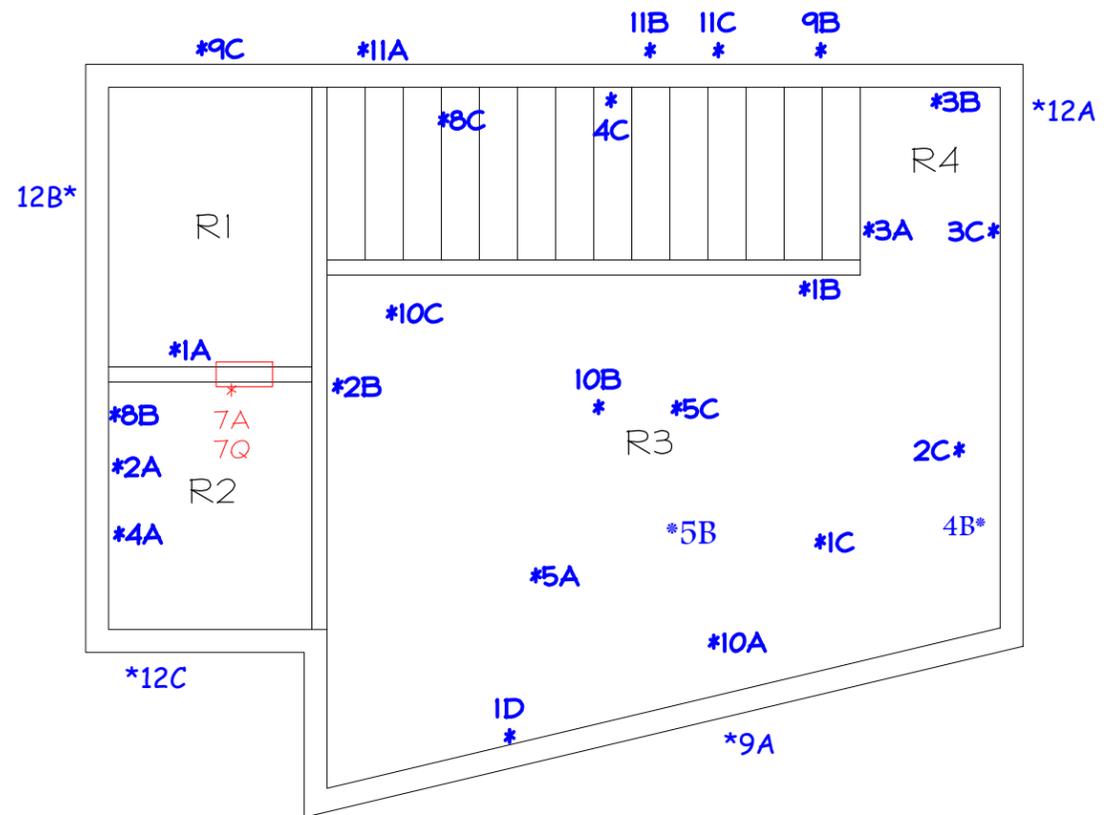
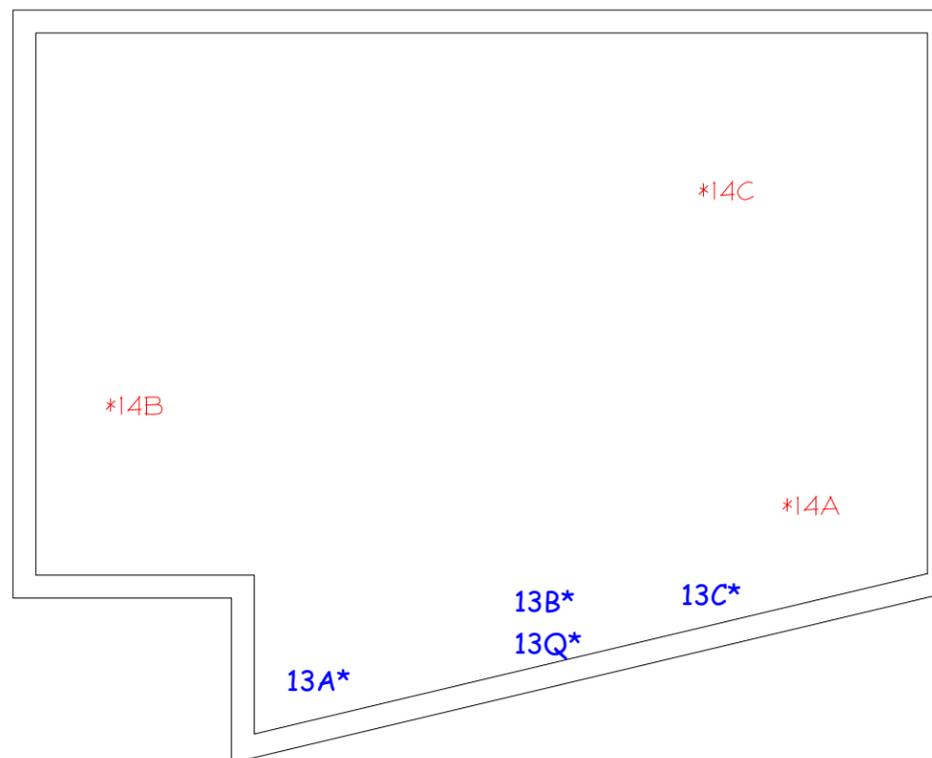
BASEMENT

MAIN FLOOR

ROOF

- R1 = Room Numbers
- 4B = Asbestos Samples (Detect)
- 4B = Asbestos Samples (Non-Detect)
- = Vent Boot Wrap Positive for Asbestos

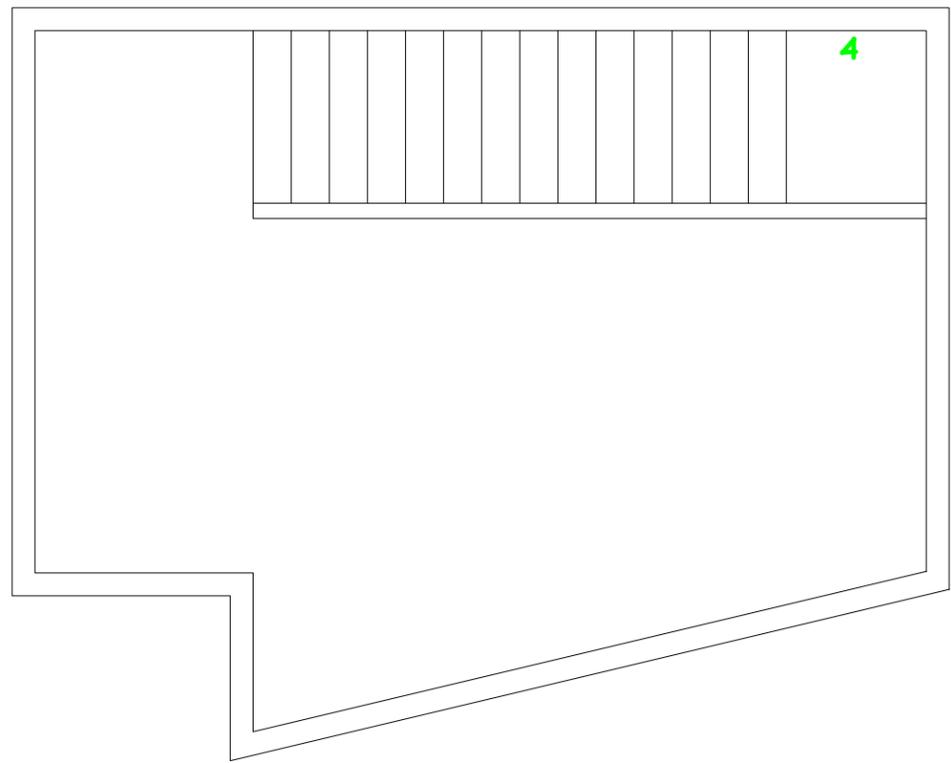
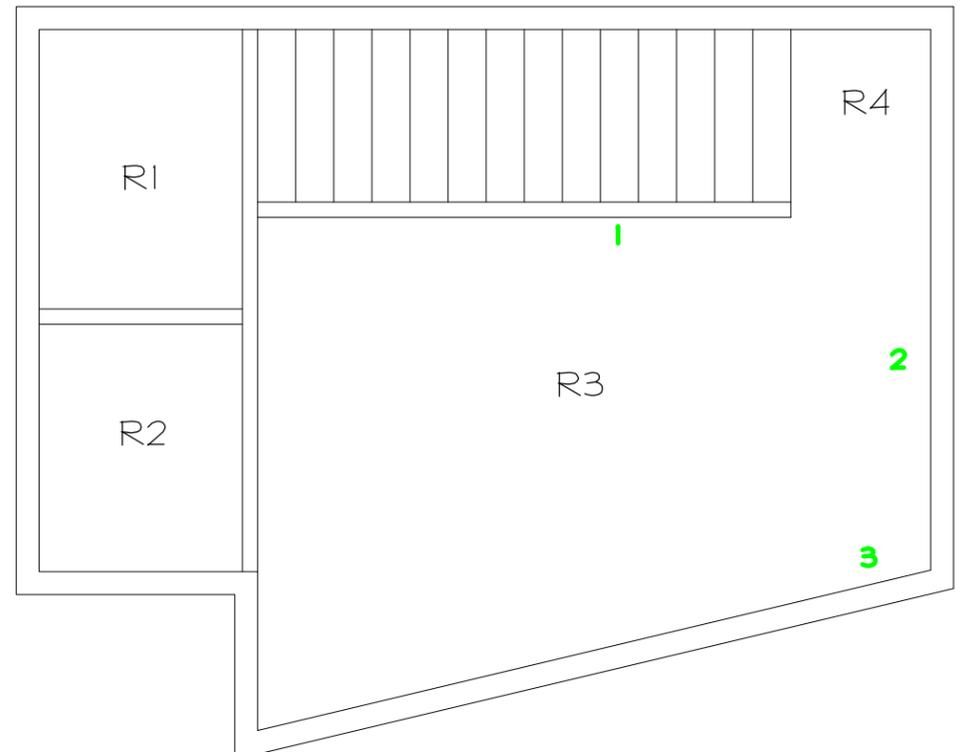
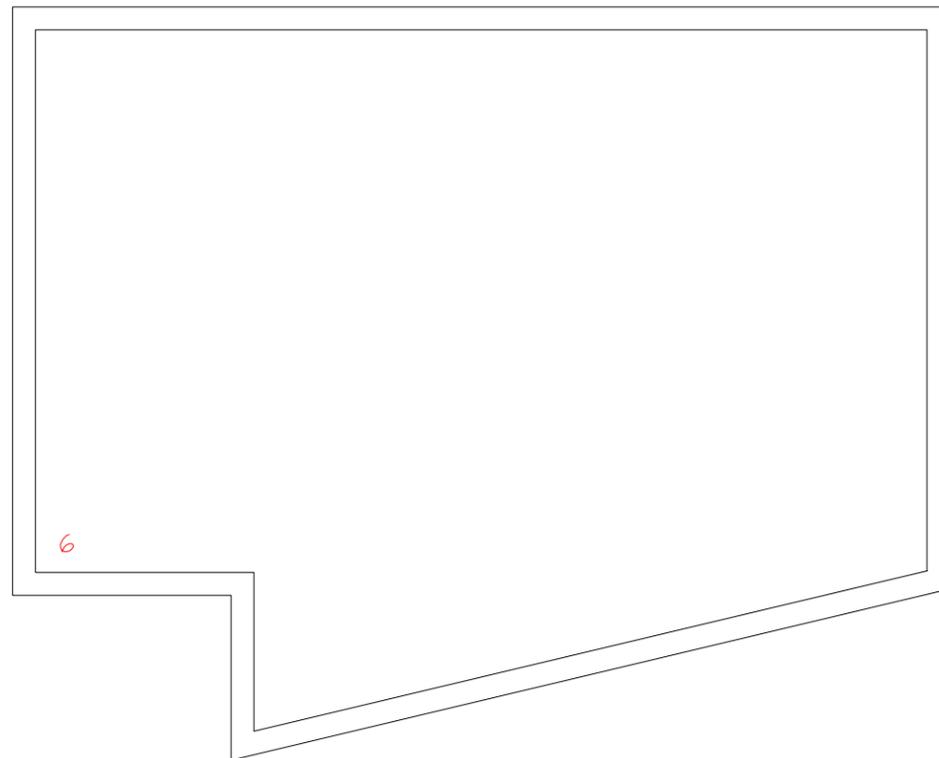
FIGURE 3 - Lead Based Paint Sample Location
CENTRAL 70 - Structure Survey Assessment Map
AP-49A
 2381 E. 46th Ave., Denver, CO
 May 17, 2018
 APEC #: 18-3066

BASEMENT

MAIN FLOOR

ROOF

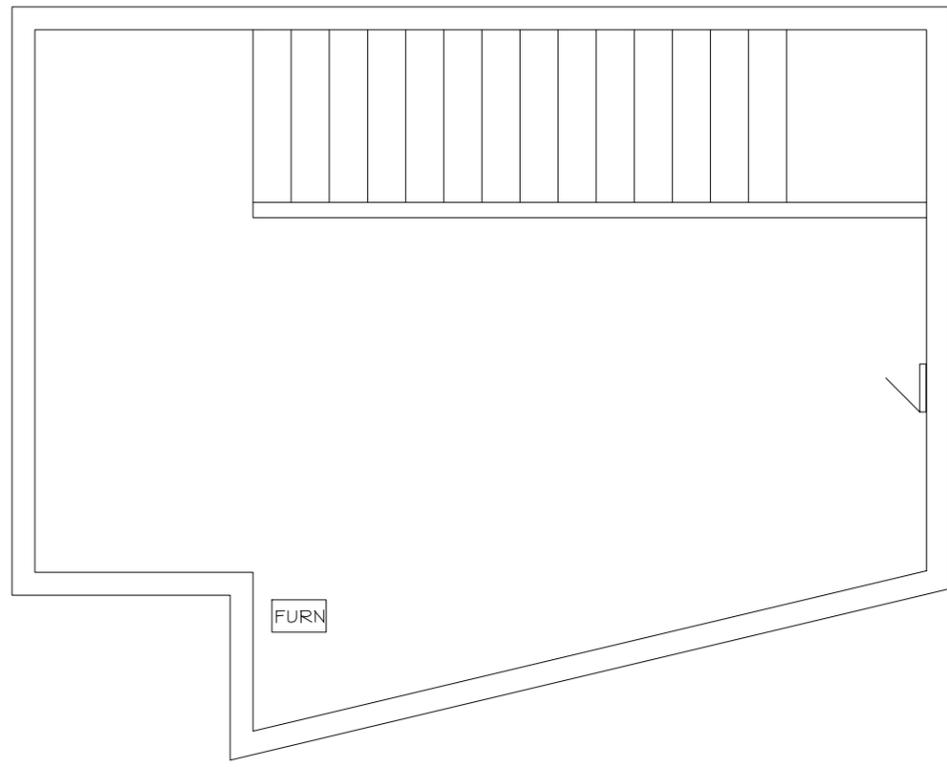
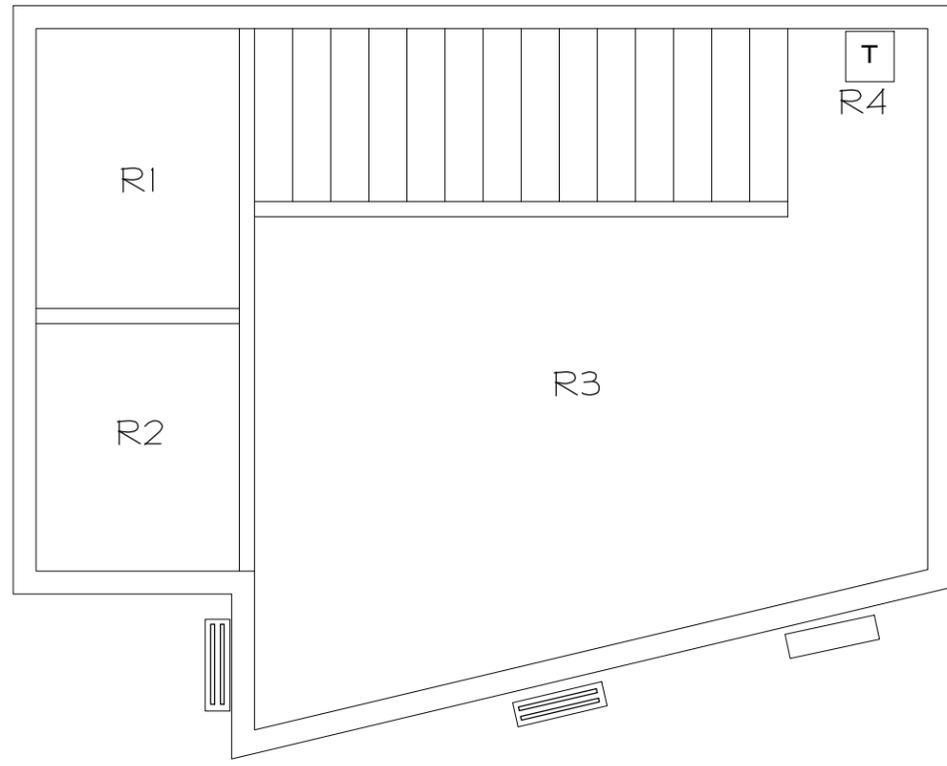
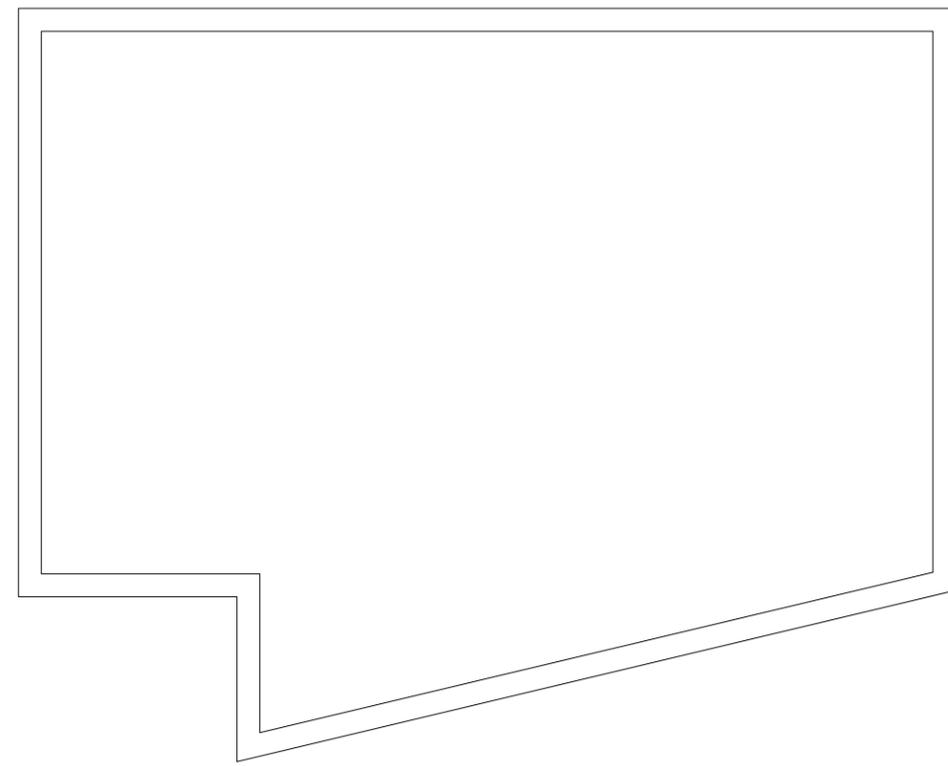
BASEMENT

MAIN FLOOR

ROOF

- RI = Room Numbers
- FURN = Furnace
- T = Thermostat
- = Breaker Panel
- = 2 Bulb Fluorescent Lights
- = NO Bulb Fluorescent Lights

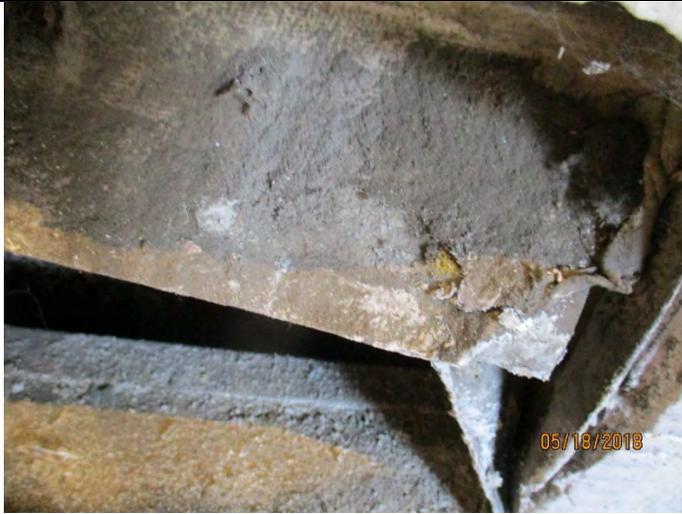
Vent Wrap

Samples Represented –
AP49A-R2-VW7A
AP49A-R2-VW7Q
AP49A-B-VW7B
AP49A-B-VW7C

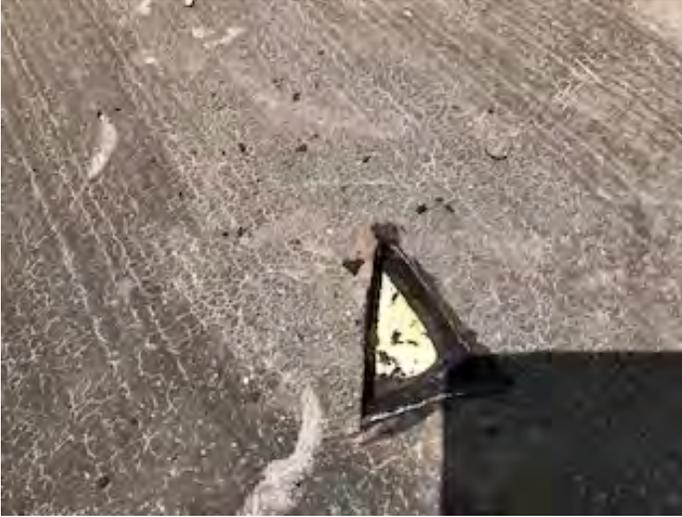
Roofing Mastic

Samples Represented –
AP49A-EX-R14A
AP49A-EX-R14B
AP49A-EX-R14C

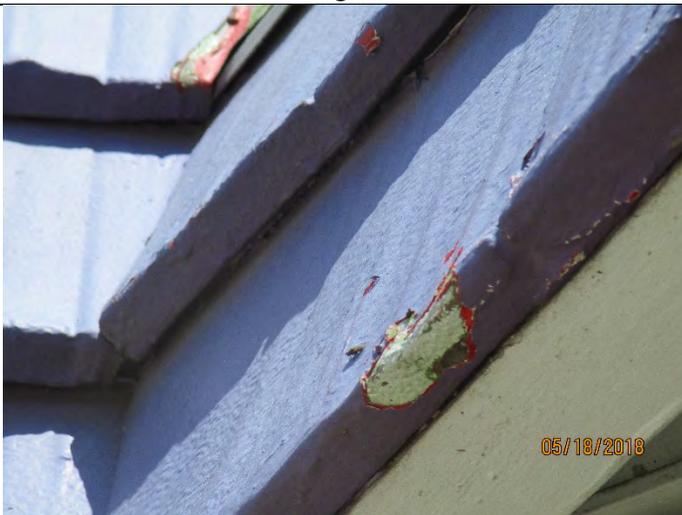
One lead sample (AP49A-EX-L-6) was found to be greater than 0.06% by weight and less than 0.5% by weight and is considered LCP (Table 3-2). The remaining 6 samples were less than the LCP and LBP thresholds, and are considered NLC. The laboratory analytical report is included in Appendix D.

Multiple Colors-LCP

Sample Represented –
AP49A-EX-L-6

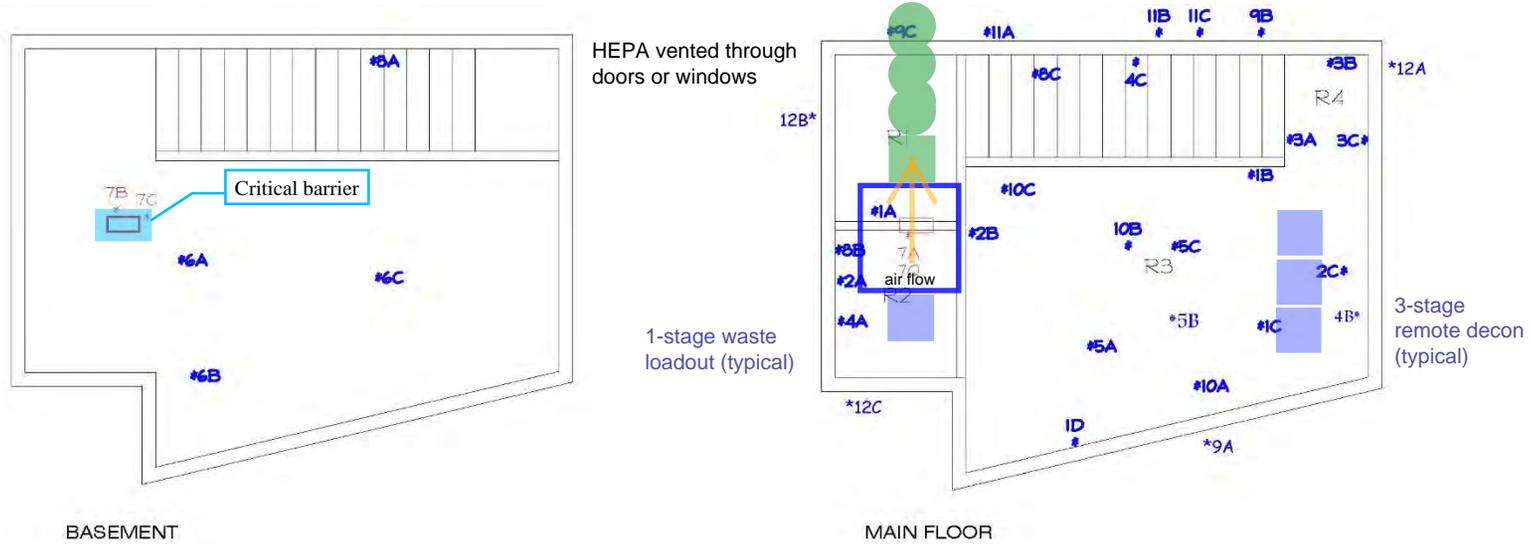
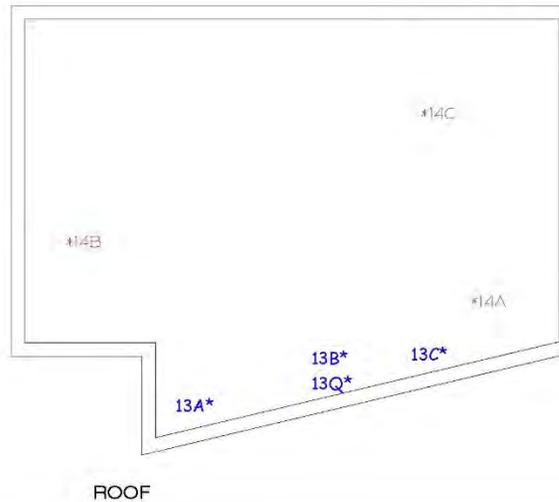
October 30, 2018 - November 1, 2018
ABATEMENT IN SECONDARY CONTAINMENT

BASEMENT

MAIN FLOOR

ROOF

- R1 = Room Numbers
- 4B = Asbestos Samples (Detect)
- 4B = Asbestos Samples (Non-Detect)
- = Vent Boot Wrap Positive for Asbestos
